Belzona Repairs 315 kW Motor Shaft

ID: 2454

315 kW electric motor shaft.

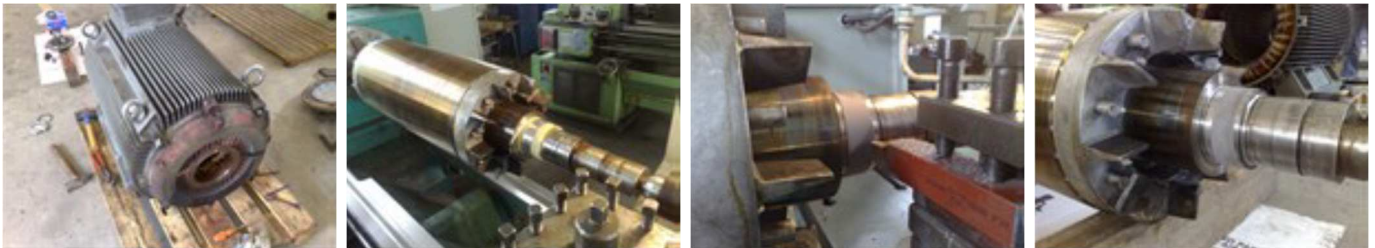
Photograph Descriptions

Shaft had been damaged by failed bearing.

1. Electric motor case
2. Damaged shaft
3. Machining of the Belzona® 1111
4. Completed job

Application was carried out in accordance with Instructions for use. Shaft was turned down and left with coarse thread before being rebuilt with Belzona® 1111 followed by machining back to original diameter.

Welding was not an option due to the high risk of thermal stress. Belzona repaired required no heat so enabled a safe cost-effective repair to be completed quickly, saving huge cost over replacement option.
