# Belzona Repairs Mould Flange

ID: 7597

Customer Location: *Aluminium producer, Slovakia*  
Application Date: *2014*

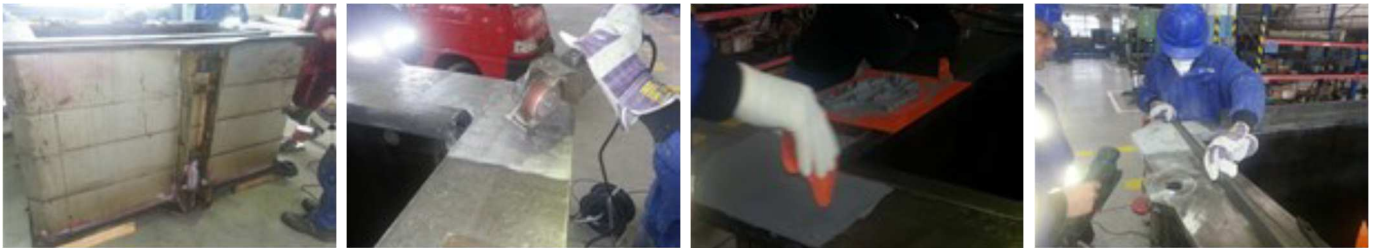
## Photograph Descriptions

*During mould manipulation workers damaged the flange leading to loss of critical dimension.*

1. Mould has massive construction
2. Surface preparation
3. Belzona® 1111 application
4. Final grinding to achieve correct level

Because the mould has massive construction it was not possible to bend sealing face back. Welding would have taken a long time. Repair with Belzona® 1111 was done very quickly.
