# Repair of The Damaged Motorcycle Fork Cover KTM

ID: 5575

Industry: Transport  
Application: ENC-Engines and Casings  
Substrate: GFRP  
Products: Belzona® 1221 (Super E-Metal)

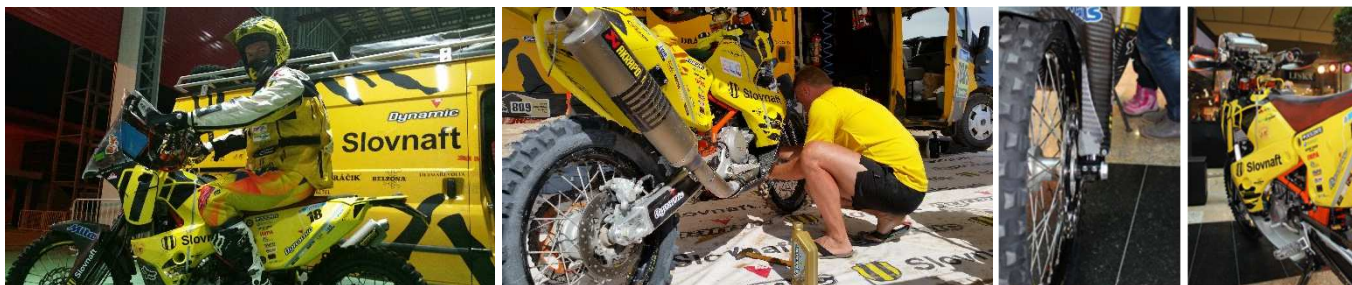
It is one of the arduous rallies in the world. Riders need to repair their machines on the run or in the evening in hard field conditions. So it is perfect for them to carry some products, which they can use due to its fast curing characteristics and which are ideal for emergency repair situations. When was broken motorcycle fork cover KTM, they have used the Belzona products to repair it.

1. Slovak rider (supported by Belzona products) with escort repair truck - fifth overall bike on the Dakar rally 2015
2. Repairs in the field conditions
3. "Emergency" repair of the damaged motorcycle fork cover KTM hold for the all race (photo from after rally promotion show
4. Motorcycle KTM - after rally promotion show

Application was carried out in accordance with Instructions for use in field conditions. The cover was dismantled, ragged by steel brush, cleaned and recovered with Belzona® 1221 together with Belzona® 9341.
